USSR

OCTOBER 1965

NATIONAL	_ PHOTOGRAPHIC INTERPRET	ATION CENTED	_
MOTALEATION NAME	GEO COORDS	PUBLICATION DATE	-
Novosibirsk KRUG Antenna	55-14-30N 083-19-30E	October 1965	
Facility		BE NO	- 2
USSR			
PHOTOGRAPHY			- ,
			2
AD AREA	REQUIREMENT		
FD-3-7		NPIC PROJECT	25
REFERENCES USATC, Series 200, Sheet (11012/66 (partial answe	r)
Location: 21 nm NE of Nov	osibirsk and 2 nm NNE of	Novyy-Sokur	•
		-10.19 DOT/OT	
. MITC OTOIL THE DE			
Status: Midstage of const		et visible	
Status: Midstage of const Activity: Construction	ruction; antennas not ye		
Status: Midstage of const Activity: Construction Support Components: Cylin	ruction; antennas not ye		c-
Status: Midstage of const Activity: Construction	ruction; antennas not ye		:- 55
Status: Midstage of const Activity: Construction Support Components: Cylin tion, and a guardhouse at road.	ruction; antennas not yed drical central control by the intersection of the		C- SS
Status: Midstage of constatus: Midstage of constatuivity: Construction Support Components: Cylin tion, and a guardhouse at road. Security: Low outer-ring Gegetation & Terrain: Cle	ruction; antennas not yed drical central control kenter the intersection of the fence	ou

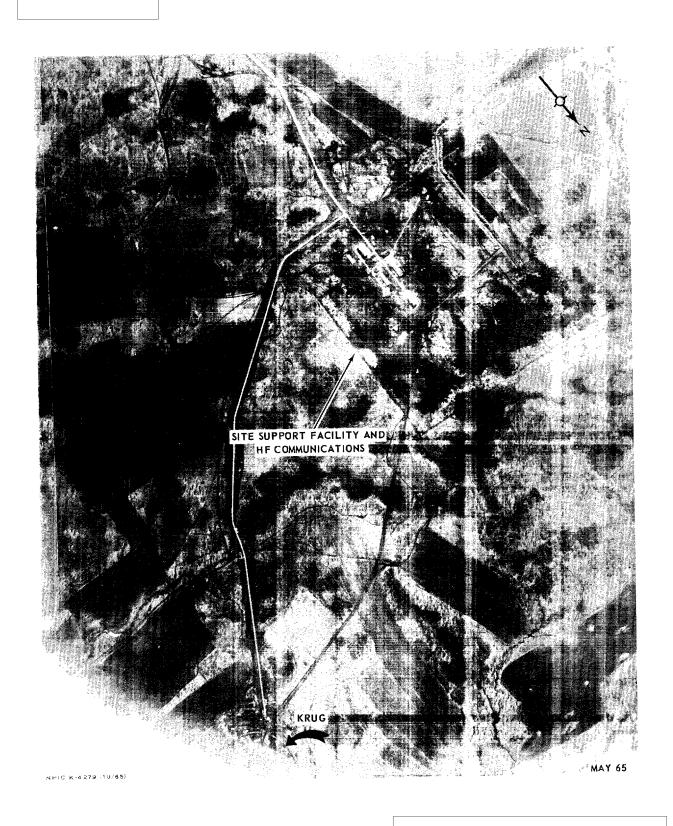
Status: Midstage of const Activity: Construction Support Components: Cylin tion, and a guardhouse at road. Security: Low outer-ring Vegetation & Terrain: Cle Site Support Facilities: tangular barrack-type buil Facility appears to be in Associated Facilities: A	ruction; antennas not yedrical central control be the intersection of the fence ared and flat 4,500 ft SW of the KRUG ldings and at least 6 ot a late stage of constructions in the communication of the stage of constructions in the stage of constr	and contains 4 large recher support buildings.	SS •
Status: Midstage of const Activity: Construction Support Components: Cylin tion, and a guardhouse at road. Security: Low outer-ring Jegetation & Terrain: Cle Site Support Facilities: tangular barrack-type bui	ruction; antennas not yedrical central control to the intersection of the fence ared and flat 4,500 ft SW of the KRUG ldings and at least 6 ot a late stage of construction the site gumnant for the s	and contains 4 large recher support buildings. ction. n facility is 4,500 ft SW	ss -
